# UNDERSTANDING REFRACTORY FAILURES IN FIRED HEATERS

A guide from SK Energy in conjunction  
with Morgan Advanced Materials

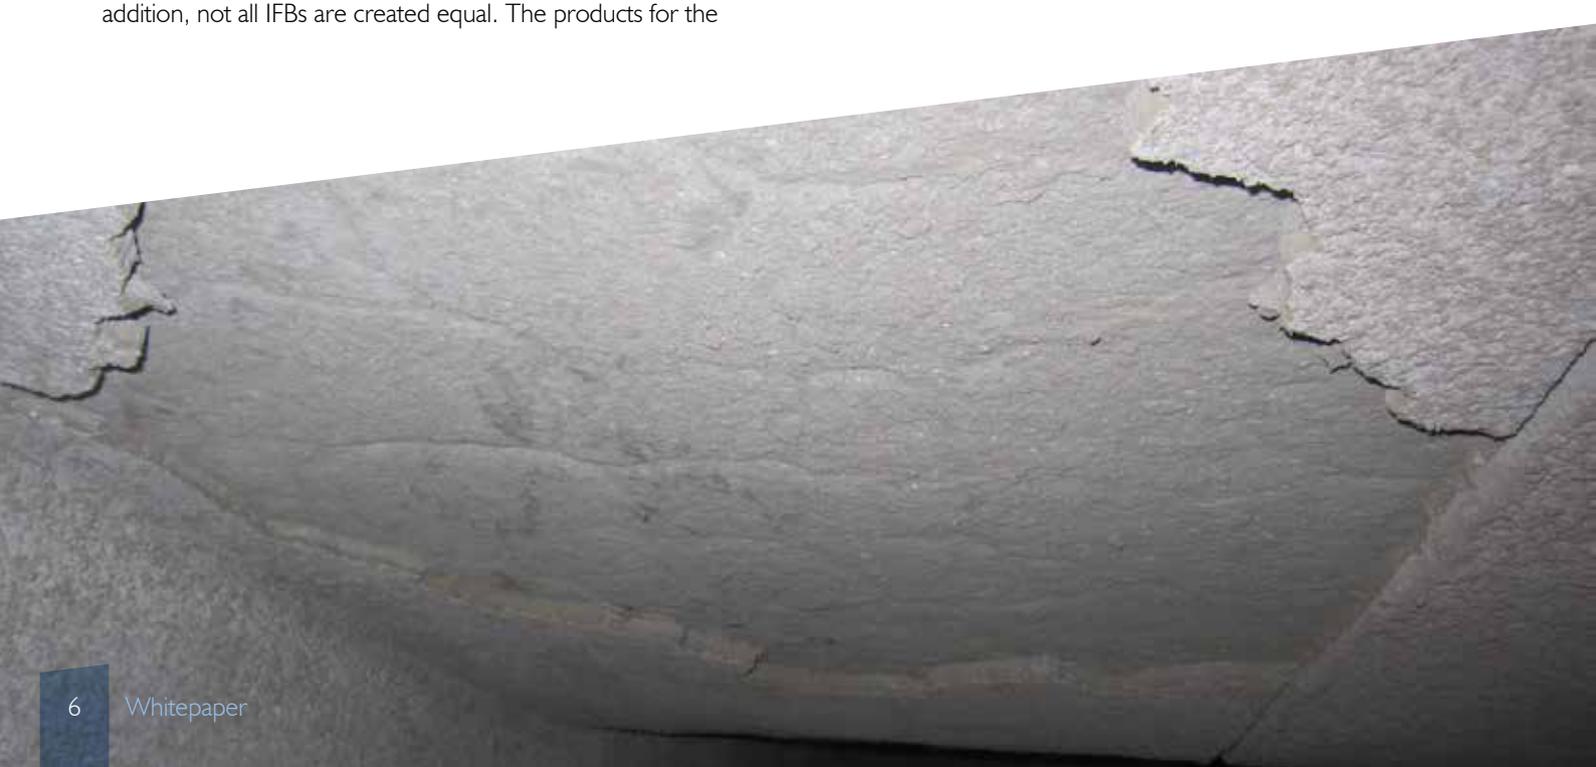
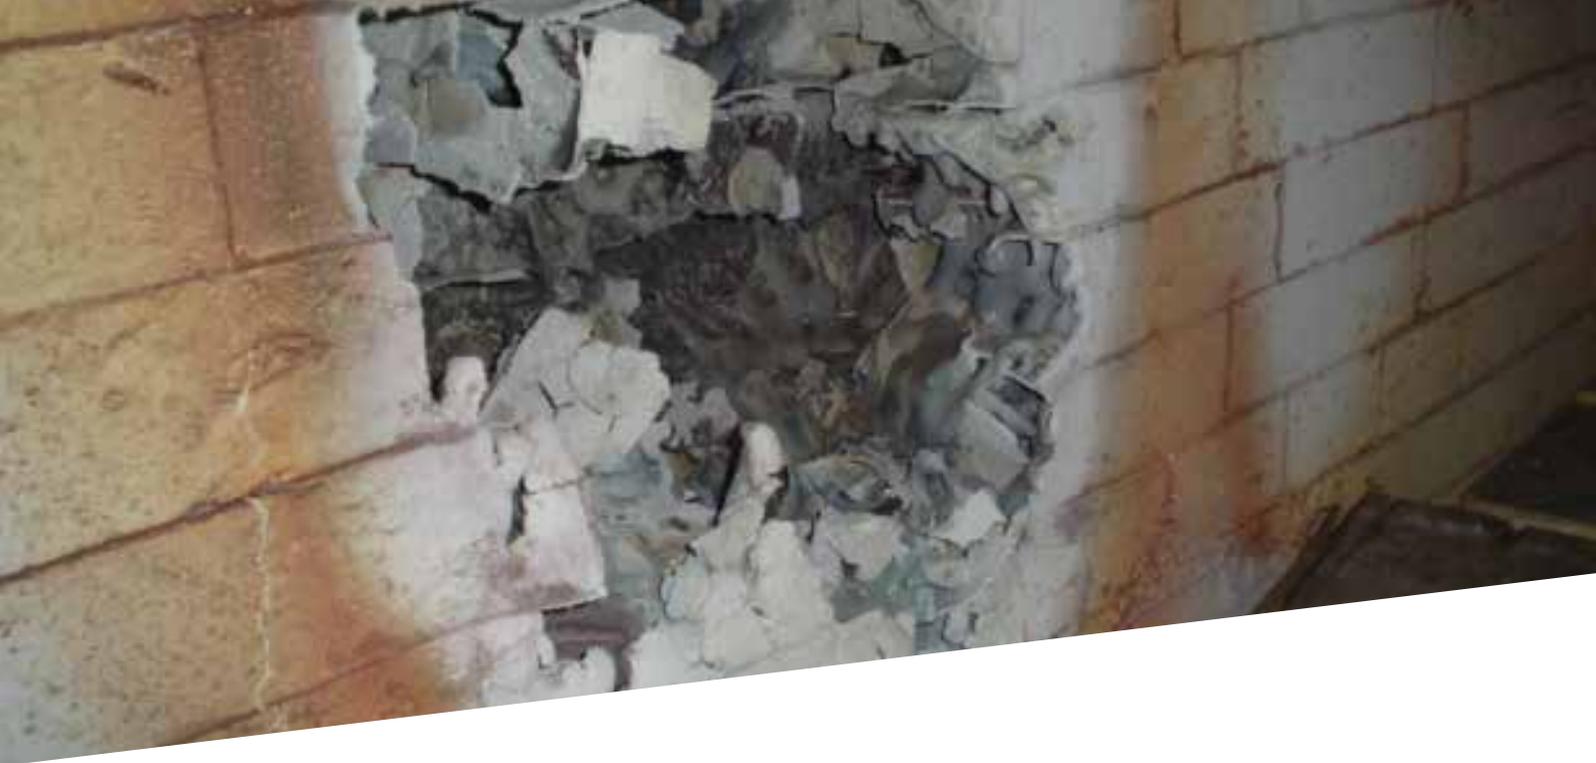
IFB linings can also suffer from poor installation workmanship. A common issue which is sometimes hidden can be where the expansion joints are mortared so not free to slide. You may not even see this as excess mortar from an adjacent brick could push into the expansion joint areas, causing the same effect.

Is the hot face brick in good shape but the wall bowed? This can be for a number of reasons including design, installation and changing operating conditions. Normally this manifests itself in the expansion joints and tie-back anchor systems. All IFB linings need to be designed for reversible thermal expansion. If there is not enough expansion allowance, the brick will need to move in some direction so you see the bowing.

With this additional expansion, a wall will also grow more vertically. If tie-backs legs are not long enough, this movement could allow them to come out of the tie-back holders. Remember, as furnace temperatures increase, IFB anchor temperatures will increase. Since most metal anchors are very weak at elevated temperatures, any increase in temperature may push the anchor past its ability to hold the wall in place or survive over long periods of time.

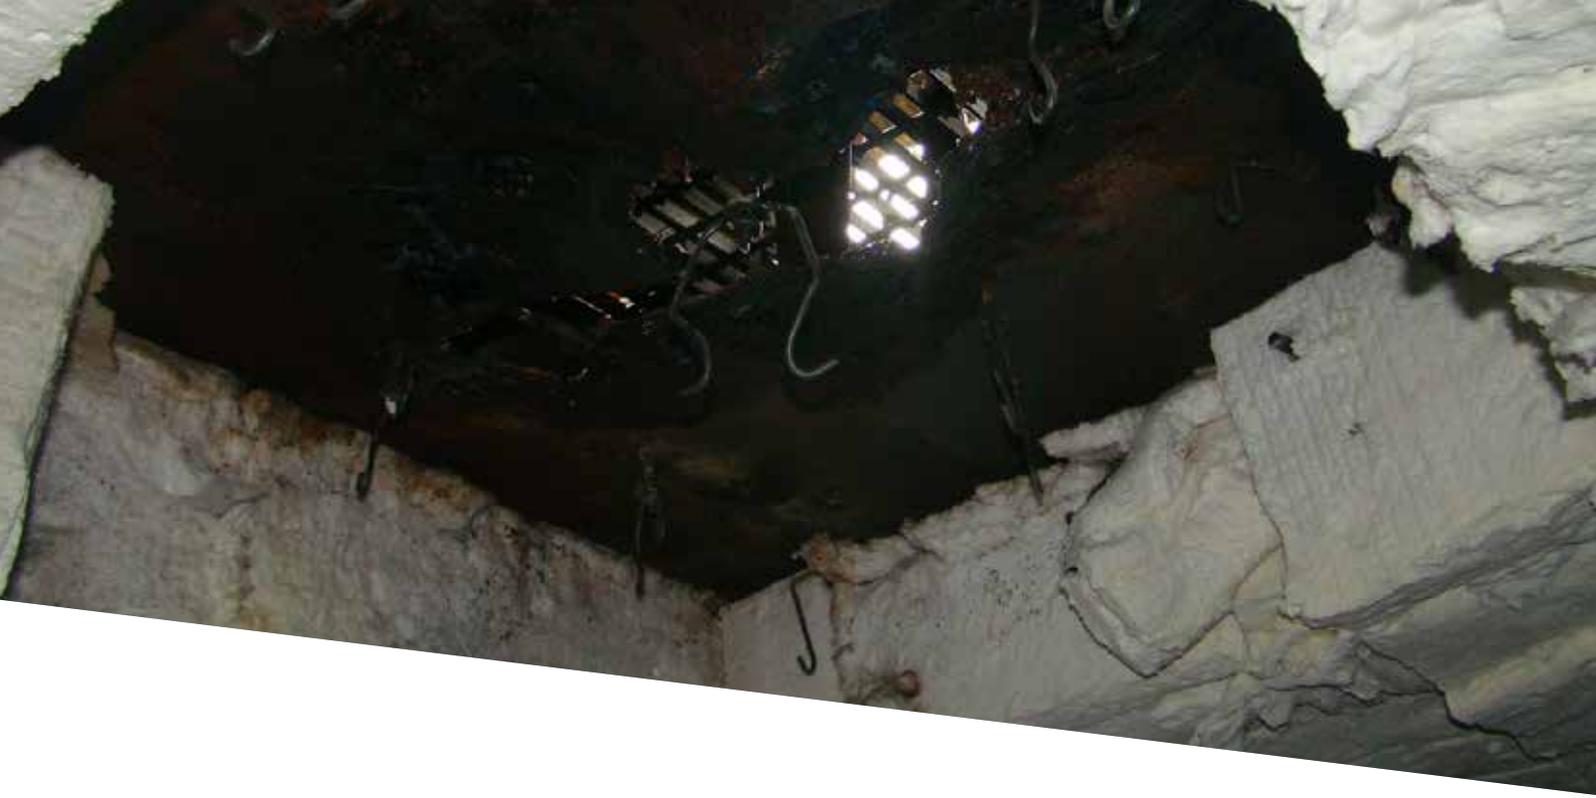
Let's take the case of peep sights. If you have an IFB wall, it's always best to cut your peep sight out of the IFB wall. This does take some skill and good design but can be readily done. To avoid the issue of mating an expanding material (IFB) rather than a material that can expand and shrink differently (castable), you really need to use a good high temperature fiber expansion joint. You want the joint to remain resilient at high temperatures to overcome the differential movements.

When using fiber walls, normally you'll have a vacuum formed peep sight. If you surround this with modules, you will have stiff and resilient materials that will both shrink. Again it is prudent to use a high temperature fiber joint between the two that remains resilient during operation. It is also easy to solve this potential issue up front by installing module peep sights that are typically cut in the field. These have been used very successfully and for many years.
